Hull Camera: Preliminary Design and Testing of its use for Assessing Biofouling on Small (<12 m) Recreational Vessels

Fisheries Research Reports

Bridgwood, S.D., 2010. Hull Camera: Preliminary Design and Testing of its use for Assessing Biofouling on Small (< 12 m) Recreational Vessels. 2010. Fisheries Research Report No. 200. Department of Fisheries, Western Australia. 16 p.

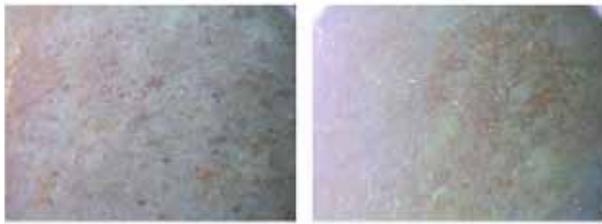
Primary

Figure 5. Examples of all three biofouling levels captured by the hull camera on the vessels hulls.

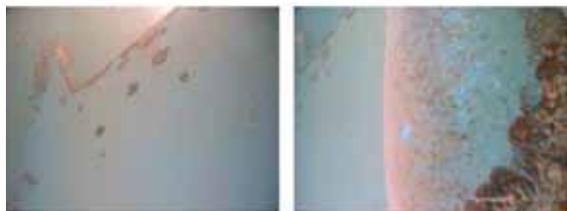
Secondary

Figure 6. Examples of secondary and tertiary biofouling levels captured by the hull camera on keels.
