# Feasibility of using remote-operated vehicles (ROVs) for vessel biofouling inspections

Draft Final Report for project DoF 10/2011

NIWA Client Report No: CHC2011-073  
Report date: August 2011  
NIWA Project: NAU11102

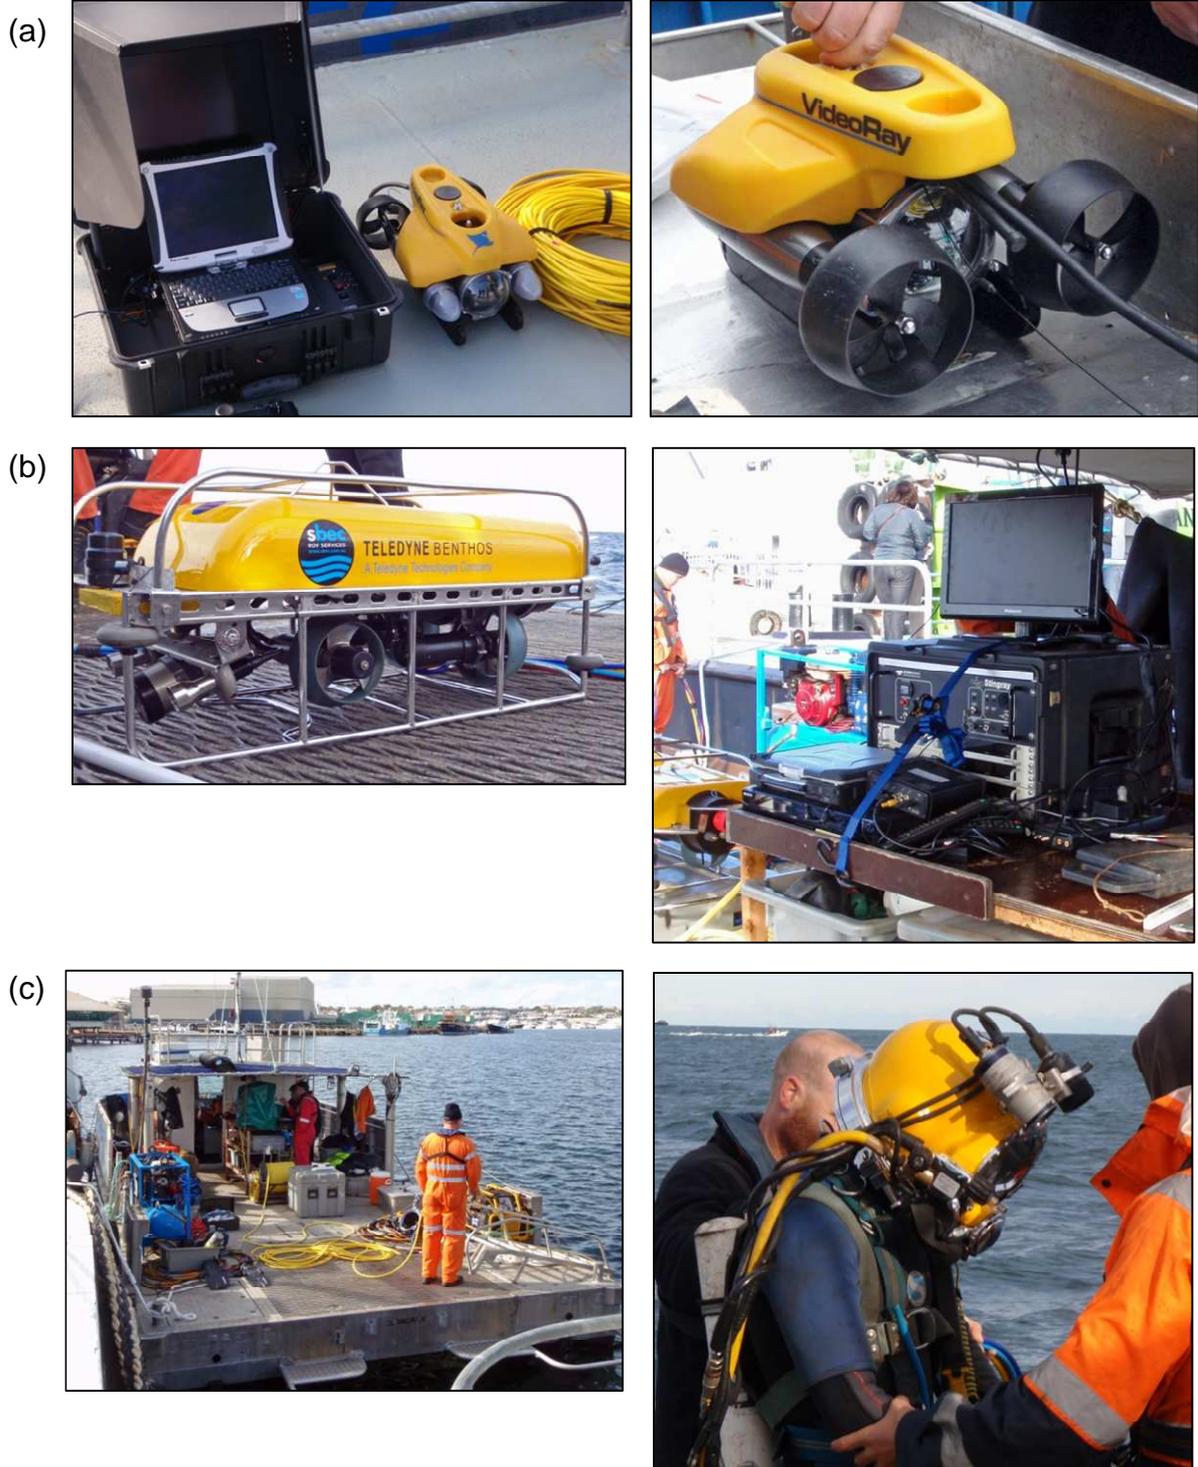
Figure 1: (a) VideoRay crawler ROV and topside control system; (b) free-flying ROV and topside control system; (c) commercial diving vessel *Cormorant* and commercial diver with helmet, CCTV and surface-supply equipment.

**1). VideoRay ROV (with crawler capability).** Imbros Pty Ltd is the Australian importer and distributor of VideoRay ROVs and also offers professional ROV services. Imbros were contracted to supply their Pro 4 Video Ray (P4 PS 300BASE) which is a small (361 x 270 x 210 mm), lightweight (6.1 kg), free-flying ROV with crawling capability (Figure 1a). The VideoRay is small enough to be deployed and operated by one person. It is neutrally buoyant and maneuverable via three thrusters (one vertical and two horizontal thrusters) and rated to a depth of 305 m. The VideoRay is equipped with a forward facing wide dynamic range underwater-optimized high-resolution camera (0.0001 lux – colour or black and white modes). The camera also has variable control tilt with 180 degree vertical field of view with two forward facing ultra high-intensity LED lights providing 3,600 Lumens. The VideoRay is controlled at the surface by a ROV operator via a 100 m umbilical capable of supplying the inspector with high-resolution CCTV footage to a topside monitor. Still images can be captured from the CCTV footage. A manipulator “arm” was also fitted to the front of the ROV to trial for collection of samples. More information on this ROV can be accessed at <http://www.videoray.com>.

**2). Teledyne Benthos ‘Stingray’ ROV (free-flying).** SBec Marine Pty Ltd are a Fremantle based ROV service provider specializing in inshore and offshore inspection and exploration work. SBec were contracted to supply their free-flying Stingray ROV. The Stingray ROV is a relatively lightweight (32 kg), mid-sized (990 x 457 x 457 mm) and transportable ROV (3 x large cases plus umbilical drum fit onto the tray of a utility vehicle) (Figure 1b). Two people are required to operate the system. It is neutrally buoyant and maneuverable via four thrusters (one vertical, one lateral and two horizontal thrusters) and rated to a depth of 350 m. The system has inbuilt heading, gyro, pressure, pitch and roll sensors and a Tritech MicronNav sonar to assist with navigation. The Stingray is equipped with a high-resolution, 18X zoom colour video camera: 470 lines resolution, 1.0 LUX minimum illumination, mounted on tilt bar +/-90Degrees, with 3.24 to 38.9mm auto iris lens, 2.2 to 53 degrees field of view horizontal (NTSC or PAL) and HID lighting systems. A Lynn Video Enhancer was also incorporated to enhance the footage and image clarity in turbid environments. For the present study, the Stingray was tethered to the topside monitoring systems via a 150 m umbilical cable that is capable of supplying the inspector with high-resolution CCTV footage

**3). SeaForce Marine Diving Services Pty Ltd.** There are many different commercial dive companies in WA and some of them are experienced in vessel biofouling inspections. SeaForce Marine Diving Services Pty Ltd (SeaForce) is one of most experienced companies in this area of work and familiar with Biofouling Solutions ISO 9001 endorsed Standard Operating Procedures for Inspecting Vessels for Biofouling and IMS. SeaForce is based in Fremantle, where the present trials were undertaken, and their divers completed the diver inspections in this study. All SeaForce divers are trained to Commonwealth of Australia’s Occupational Diving ADAS Part II and III and operate in accordance with Australian Standard 2299.1:2007. All diving operations undertaken by SeaForce during this project were conducted from their 12 x 5 m catamaran, the *Cormorant* and included a six-man dive team (skipper, two deckhands, a dive supervisor, standby diver and diver) (Figure 1c). Divers used Kirby Morgan Superlite-17B surface-supplied diving helmets equipped with lights, communication and real-time CCTV. Divers also used an independent underwater camera capable of capturing high-resolution (10MP) digital photographs.

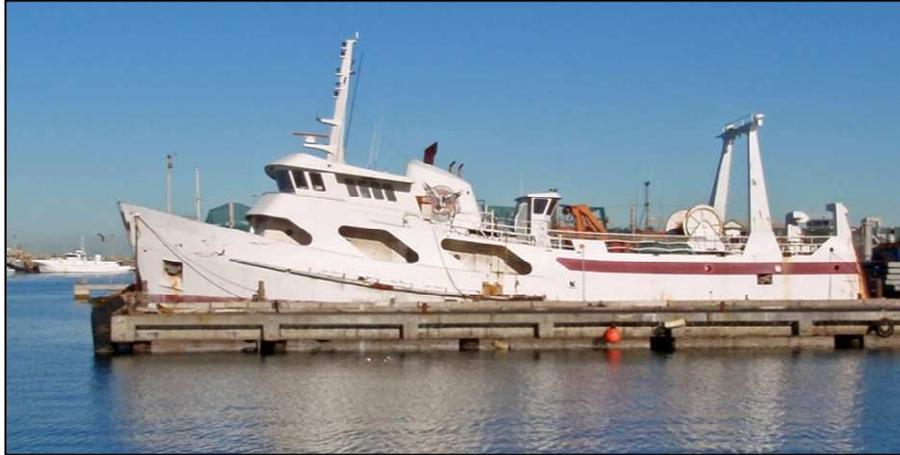
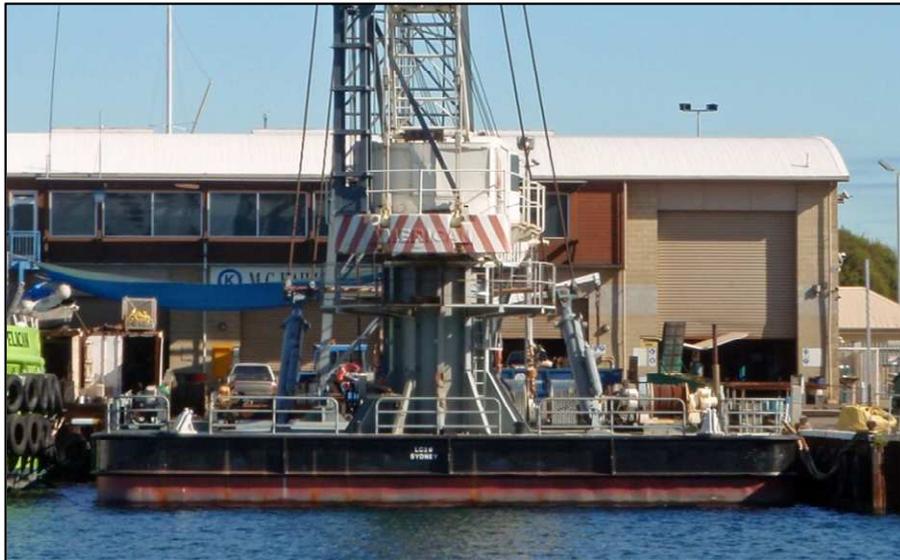
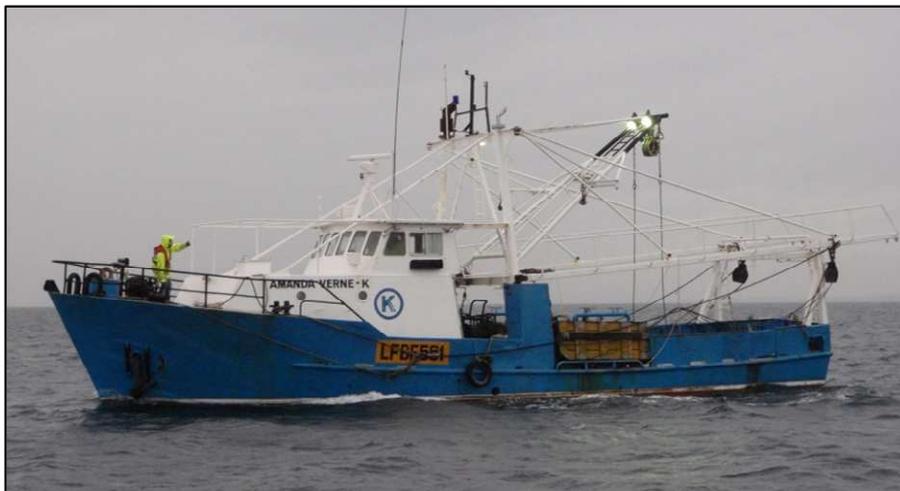
Figure 2: The vessels inspected during the field trials. (a) *Comet*; (b) *LC-20*; (c) *Amanda Verne K* (identical in build to the fourth vessel, the *George Michael K*).

The initial intention of this project was to target vessel types that are routinely subject to biofouling inspections in WA waters (e.g., anchor handling vessels, oil rig supply vessels, etc.). However, gaining access to such vessels proved difficult and compromised the timelines of this project. Fremantle-based Kailis Bros Pty Ltd arranged access to four vessels that were available for the diver and ROV trials for the duration of the project: a stern trawler (*Comet*, 40 m), a dumb barge (*LC-20*, 33 m) and two fishing trawlers (*George Michael K* and *Amanda Verne K*; both 18.3 m) (Figure 2). The *LC-20*, *George Michael K* and *Amanda Verne K* routinely operate in WA waters and had received their most recent antifouling coating within approximately 18 months prior to this study. In contrast, the *Comet* has resided in her present location within the Fremantle Fishing Boat Harbour for the past 8 years and has not received antifouling treatment during that time.

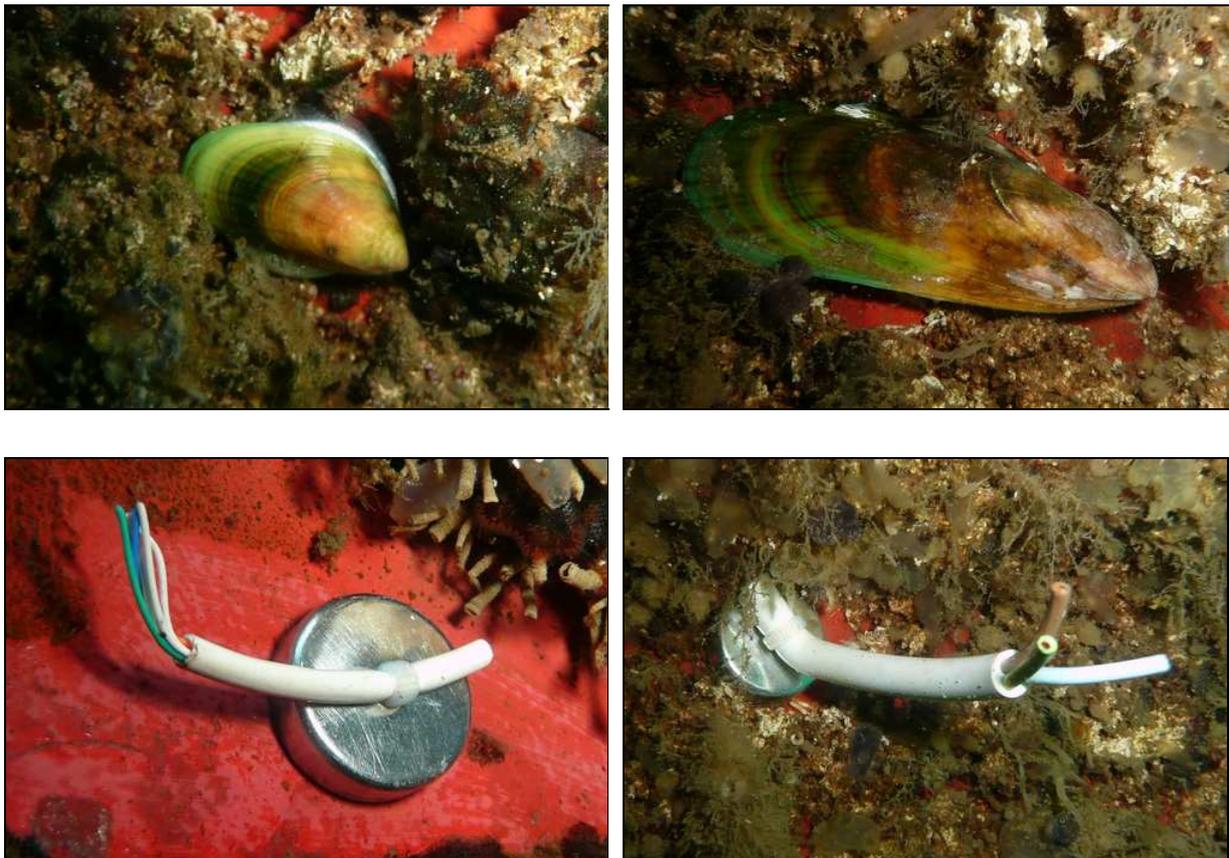
**Figure 4: The various type and size of target IMS mimics used to evaluate the ability of the three methods to detect target IMS. Top = Asian Green Mussel look-alikes (left = small 15-20 mm; right = large 60-90 mm); bottom = invasive tubeworm look-alikes, (left = small 20-30 mm; right = large 60-90 mm).**

To evaluate each inspection method's ability to detect particular target IMS, artificial biofouling organisms resembling well-known IMS were hidden around the hulls of the four vessels. These 'mimics' were attached to the hulls via magnets and deployed by a diver (a full description of the process is provided below). There were two types of mimics: bivalves and tubeworms. The bivalves were made to resemble the Asian green mussel (*Perna viridis*) and were constructed from empty New Zealand Greenshell mussel (*Perna canaliculus*) shells filled with builders' resin and a magnet attached. The tubeworms were made to resemble *Ficopomatus enigmaticus*, *Hydroides dianthus* or *H. sanctaecrucis* and were constructed from white electrical cable attached to a magnet (Figure 4). Each type of 'species' had two length classes: small (mussels 15-20 mm; tubeworms 20-30 mm) and large (mussels 60-90 mm, tubeworms 60-90 mm). Prior to the start of the field trials, the diver deploying the mimics was asked to select a number between 15 and 25. He was asked to not disclose this number to any of the other divers, inspectors or ROV pilots. The diver chose 25 mimics and without the knowledge of the inspectors, dive supervisors, inspection divers and ROV pilots, this number of mimics was hidden around each of the vessels prior to each inspection.

The diver placed the mimics haphazardly around the submerged hull and niche areas of each vessel. While the total number of mimics selected (i.e., 25) had to remain consistent across each vessel, the combination of mimic type and size was left to the deploying diver. During the inspection, the topside inspectors recorded, for each hull and niche area, the

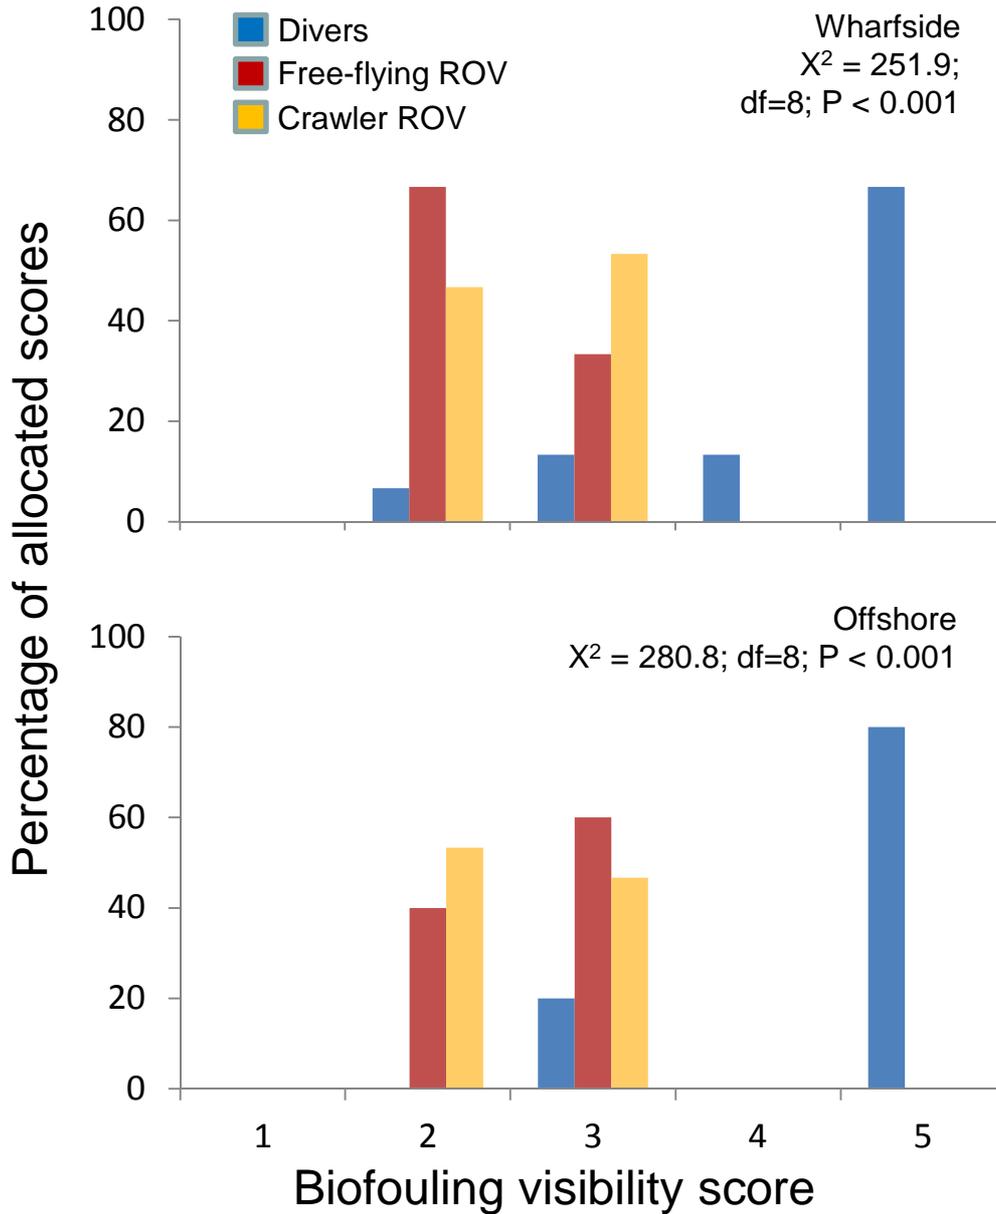
**Figure 1: Distribution of biofouling visibility scores (1-5) allocated to n=15 still images taken during vessel inspections by divers or ROVs. Diver images were taken with a handheld 10MP camera, ROVs still images were captured off the CCTV footage.**

The still images taken by the divers during both the wharfside and offshore inspections were generally of very high quality, and of a higher clarity and resolution than those captured directly off the ROVs' CCTV footage (Chi-square,  $P < 0.01$ ; Figure 5; Figure 6). On average, ~75 % of still images taken by the divers were allocated a biofouling visibility score of 5. In these images, biofouling organisms and mimics could be clearly distinguished to taxon and in some cases to genus or species. In contrast, all of the images taken by the ROVs were

allocated a score of 2 (enabling detection of biofouling presence but not to taxon level) or 3 (enabling biofouling detection and differentiation of some broad taxa) (Figures 7 and 8).

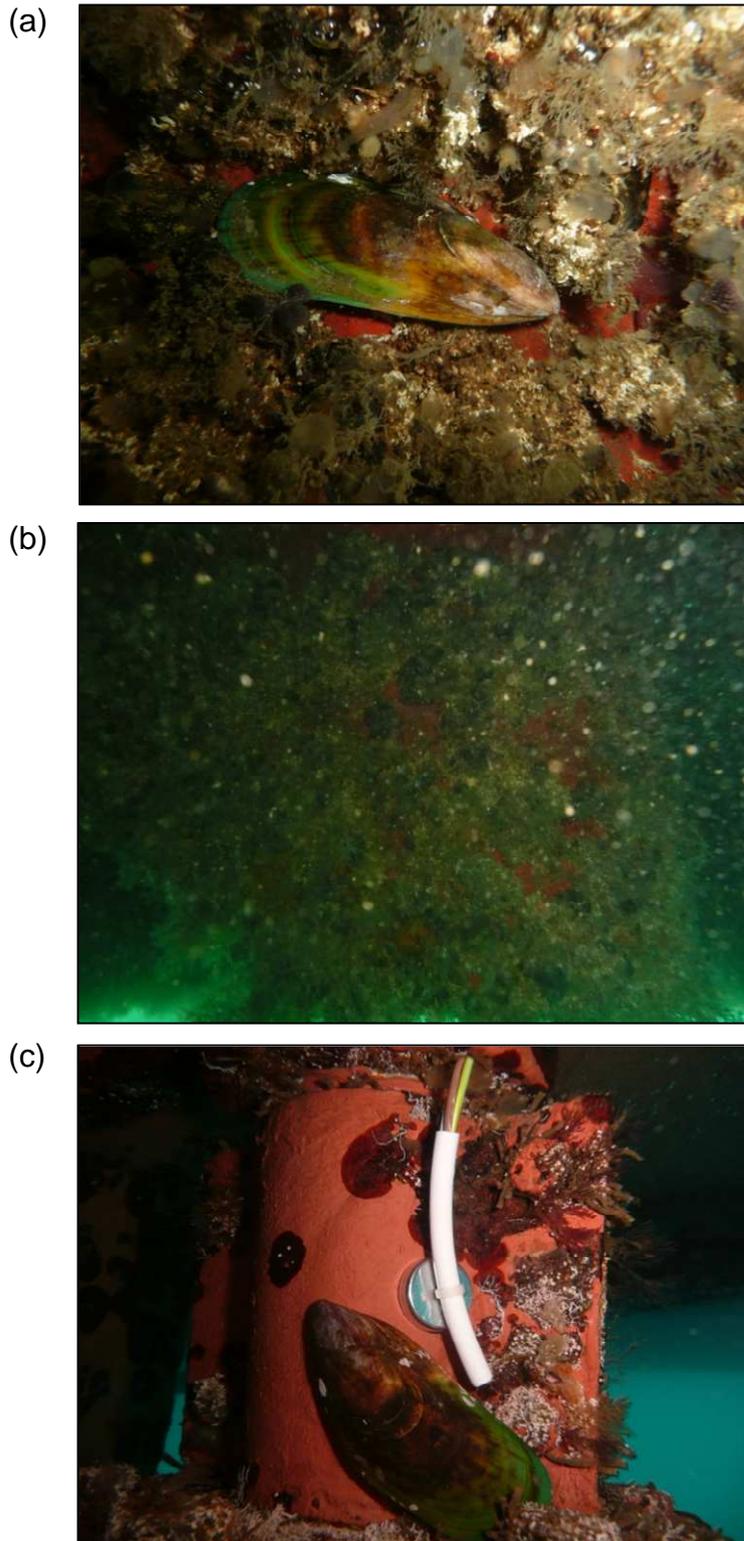
**Figure 6: Inspection still images taken by commercial divers using a handheld digital camera. (a) large bivalve within other biofouling; (b) biofouling assemblage on the *Comet* obscured by disturbed sediment; (c) large bivalve and tubeworm on rudder shaft.**

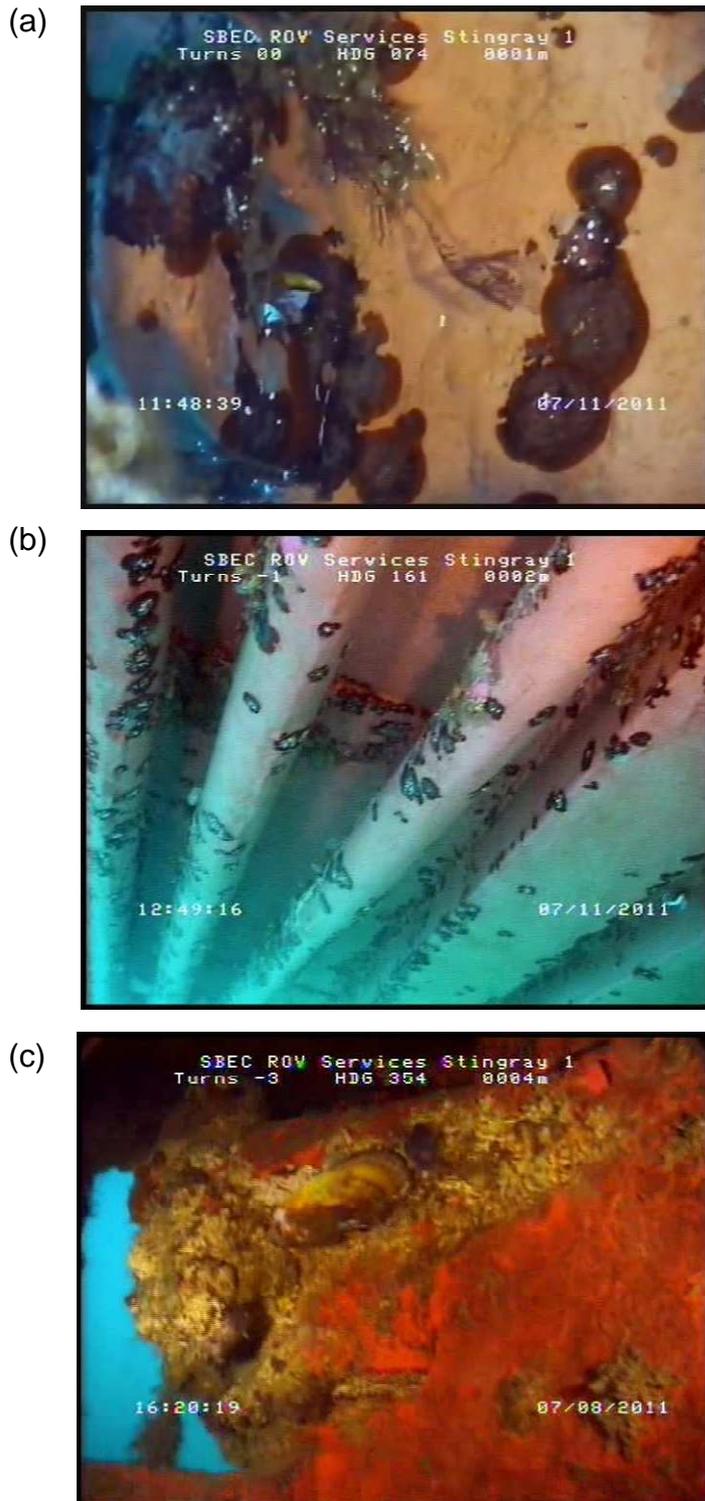
**Figure 7: Inspection still images taken by the free-flying ROV (captured from CCTV). (a) small bivalve within bryozoans and other biofouling (b) bryozoans and other biofouling on cooling pipes; (c) bivalve within other biofouling.**

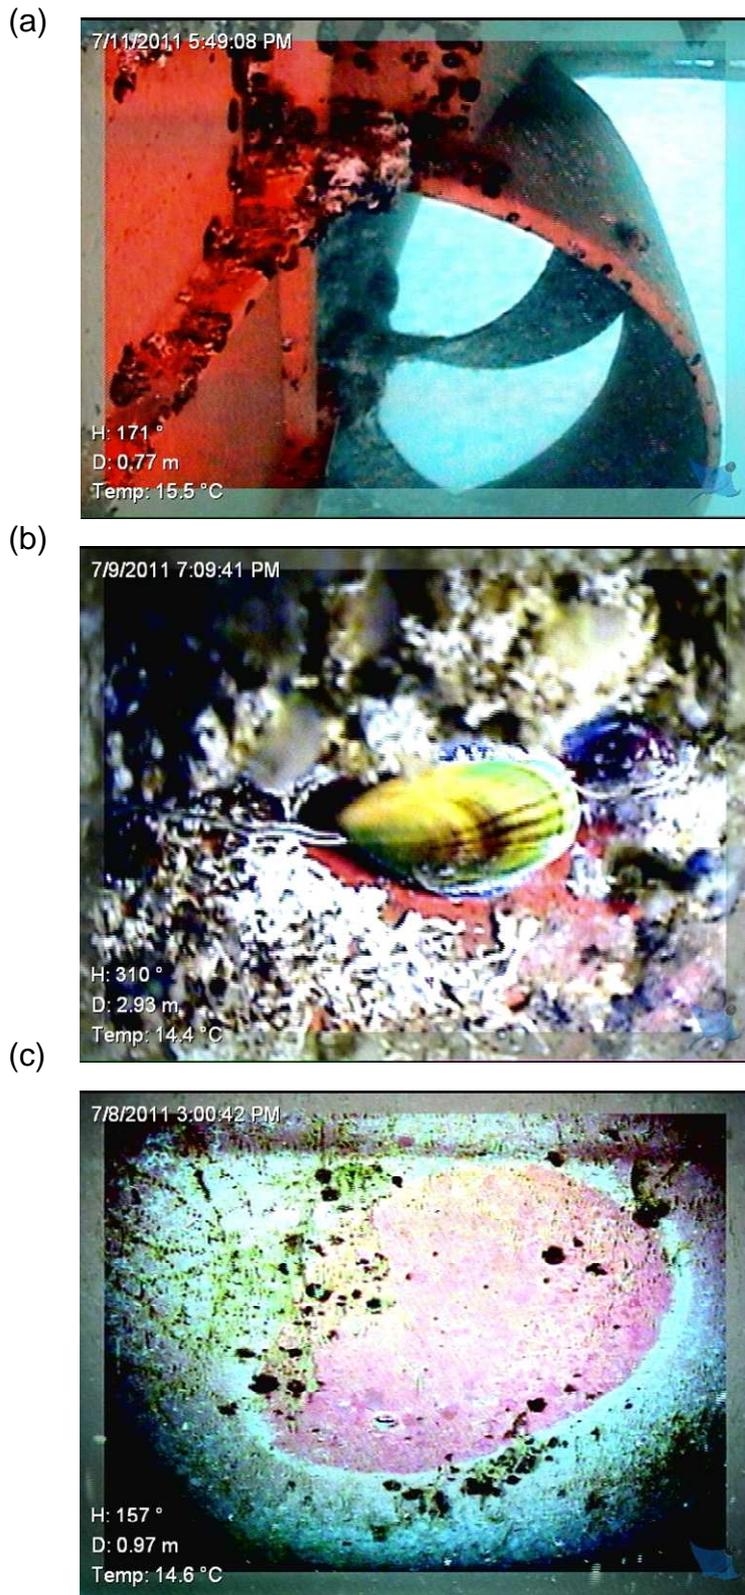
**Figure 8: Inspection still images taken by the crawler ROV (captured from CCTV). (a) rudder and propeller on the *George Michael K*, (b) small bivalve, (c) patch of bryozoans and microfouling on the *LC-20*.**

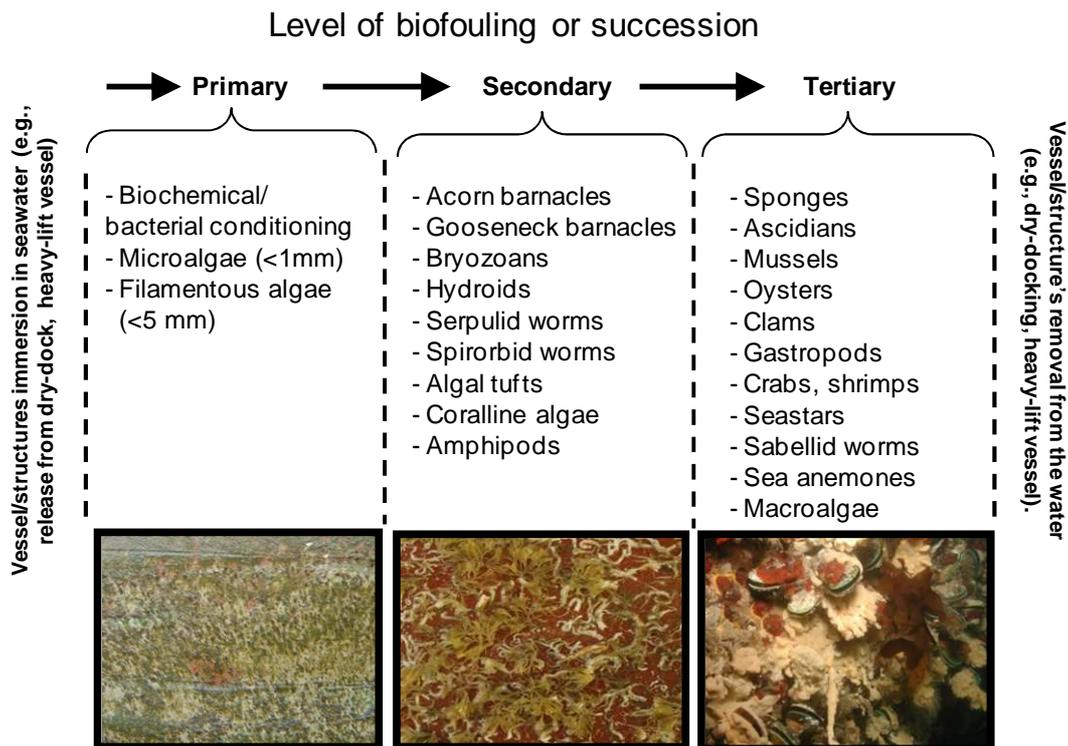
**Figure 9 A simple, but pragmatic approach to assessing biofouling risk using three levels of biofouling or succession.**

The Commonwealth of Australia has devised a simple, but pragmatic method of assessing the risk and likelihood of vessels/infrastructure containing NIS. The colonisation and accumulation of biofouling on surfaces submerged in sea water follows a very complex process from the initial settlement of microscopic organisms to the establishment of macroscopic biofouling organisms. In its simplest form, the biofouling process that occurs over a period of time (such as the in-service period of a vessel/structure) can be classified into three main categories that can be used to assess a biofouling community at the time of observation (i.e., primary, secondary, and tertiary levels of biofouling; see Figure 9 below). However, it is important to emphasise that these three categories are not entirely definitive as they are constantly evolving and tend to overlap.

Primary biofouling begins the moment a vessel/structure's hull is submerged in sea water, with immediate biochemical and bacterial conditioning followed by colonisation by bacteria, diatoms, protozoans and multi-cellular organisms. Such conditioning and colonisation of microscopic organisms provides a substratum for more visible organisms, such as filamentous algae, some of which are resistant to the toxic biocides contained in antifouling coatings. The establishment of these organisms tends to provide a suitable, but not necessarily mandatory, substratum for the settlement of secondary biofouling organisms, which tend to be the most dominant and frequently encountered biofouling organisms on vessel/structure hulls. Secondary biofouling communities are likely to progress to tertiary biofouling, particularly in niche areas of vessels/structures that are protected from strong hydrodynamic forces, when vessels remain stationary for long periods of time, or simply over longer in-service periods.
