# In-water hull cleaning and filtration system: In-water cleaning trials

26-28 November 2012

# IN-WATER HULL CLEANING AND FILTRATION SYSTEM: IN-WATER CLEANING TRIALS – 26-28 NOVEMBER 2012

July 2013  
Version 3.3

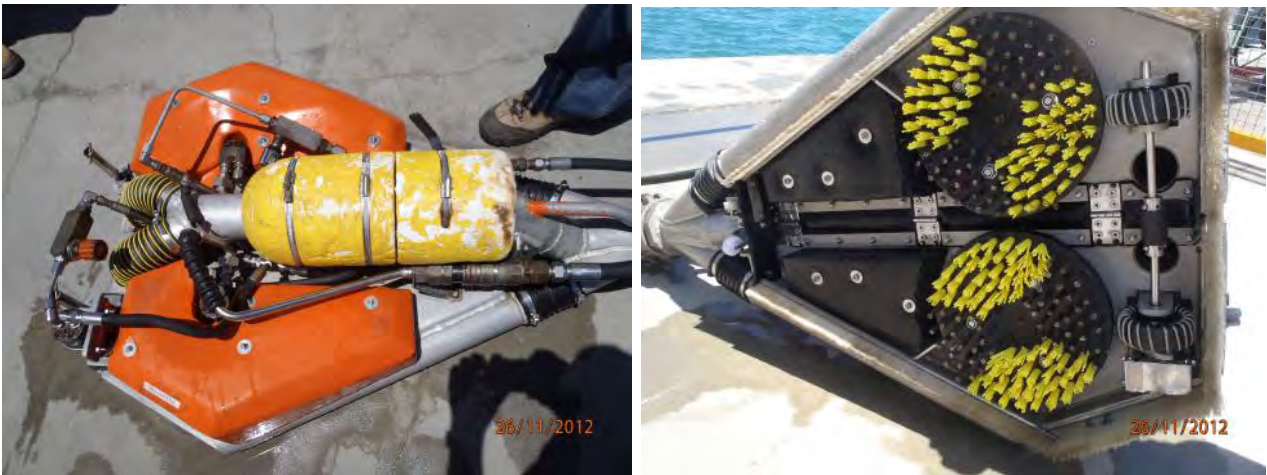
Figure 2.1 Upper and lower views of the *MkII Envirocart*

The *MkII Envirocart* has two counter-rotating discs to which 300 mm diameter brushes or bladed discs are attached (Figure 2.1). The discs are hydraulically driven, and the total width of clean in one pass is 700 mm. The chassis and drive systems both have scissor actions that enable the cart to clean flat and curved surfaces including, for example, the turn of the bilge. The lower rim of the cart body is fringed by a shroud of dense, flexible bristles that act to contain debris within the area of suction, and there are two forward wheels and a rear jockey wheel for movement and manoeuvrability across the surface to be cleaned. Suction of debris is generated by the submersible trash pump and hydrodynamic vortices generated by the brushes, and water and material is drawn through ports to a central and two lateral suction lines which lead into the 4” hose to the trash pump (Figures 2.2, 2.3). A foam float is fitted to the upper side of the cart to provide neutral buoyancy of the unit underwater (Figure 2.3).

- Combination steel and nylon bristle brushes for heavy fouling removal on scrubbable, biocide-free coatings or other hard substrates (Figure 2.1);
- All nylon bristles for biocidal conventional or copolymer antifouling coatings; and
- 45° nylon blades for contactless cleaning (Figure 2.4).

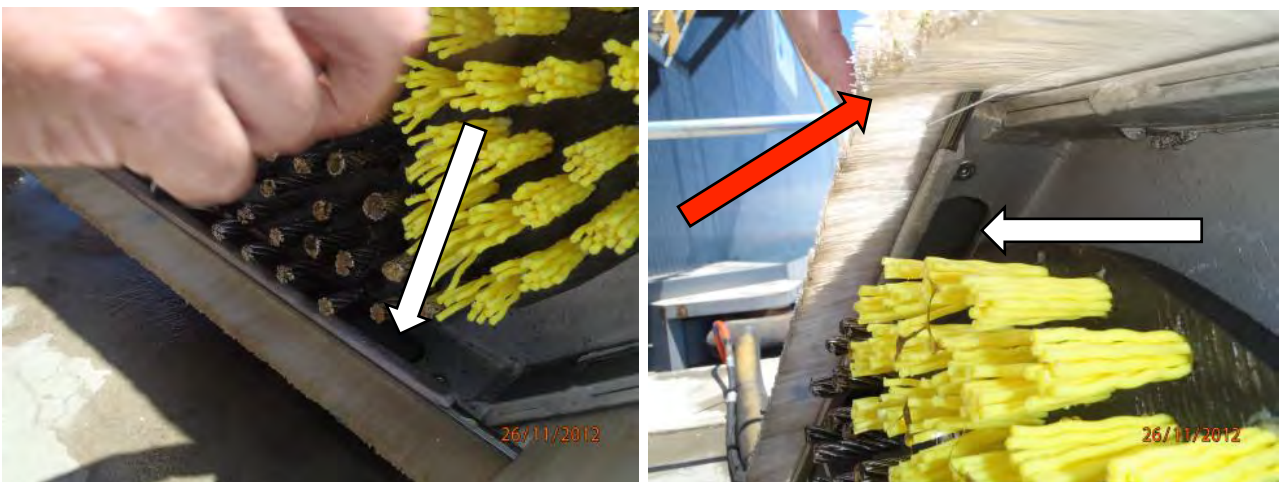
Figure 2.2 Under surface of cart showing suction ports (white arrows) and shroud (red arrow).

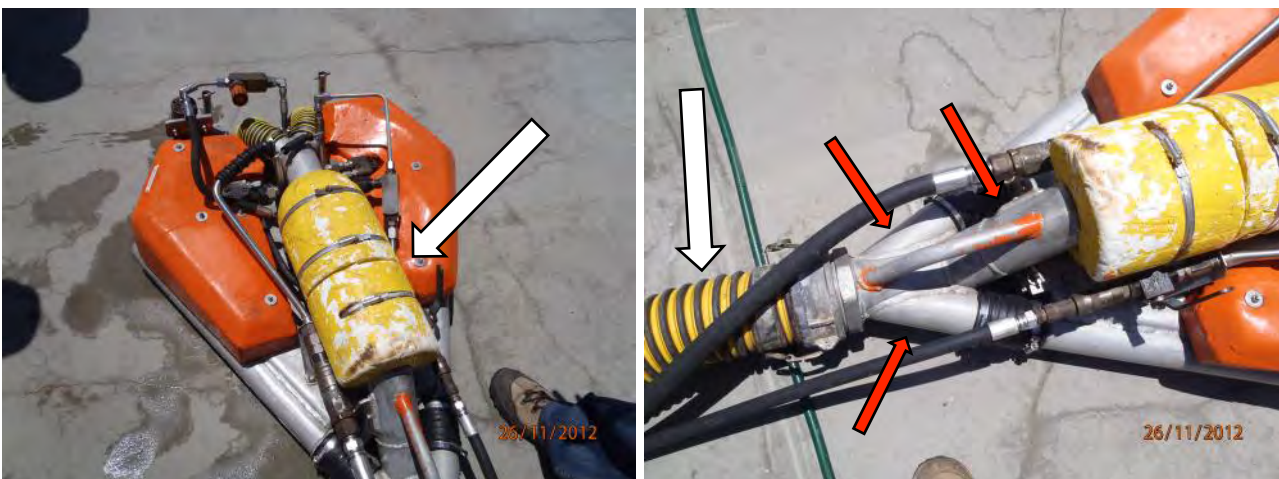
Figure 2.3 Upper surface of cart showing, left, buoyancy float and, right, suction outlets (red arrows) and hose (white arrow).

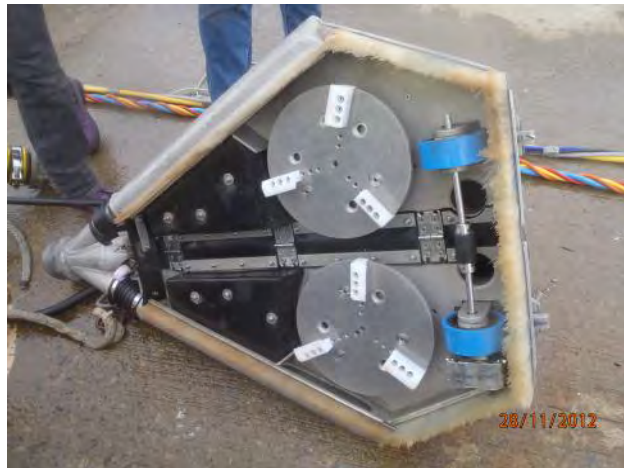
Figure 2.4 Cleaning heads with non-contact nylon blades.

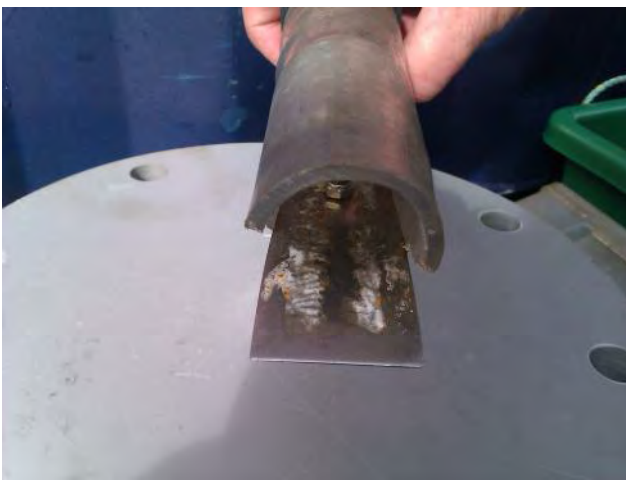
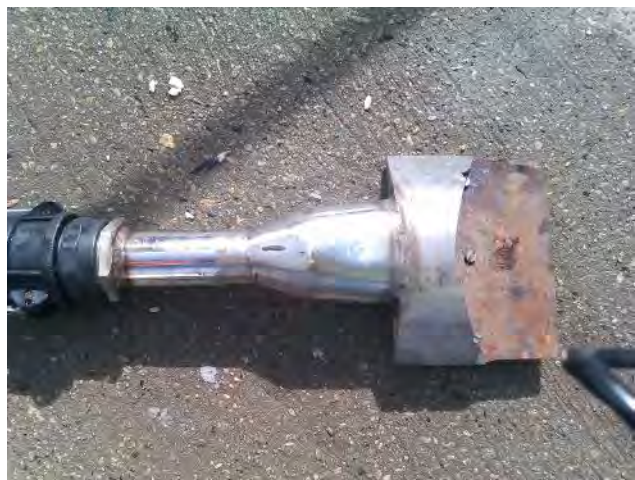
Figure 2.5 40 mm (left) and 100 mm (right) shrouded hand-cleaning blades.

For small areas, such as along weld lines and bilge keels, shrouded hand scrapers have been designed. Two sizes, 40 mm and 100 mm blade width scrapers are currently available (Figure 2.5).

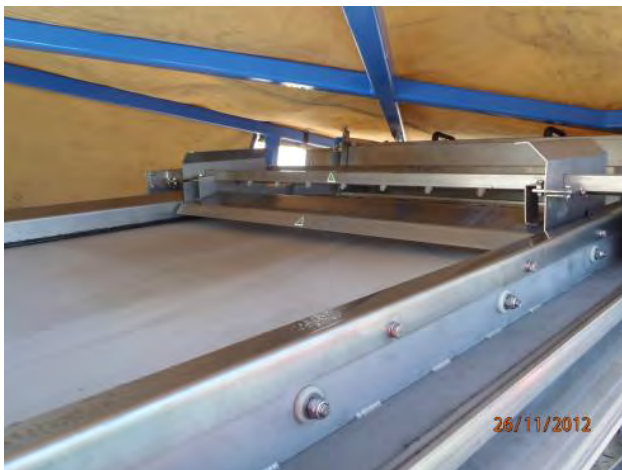
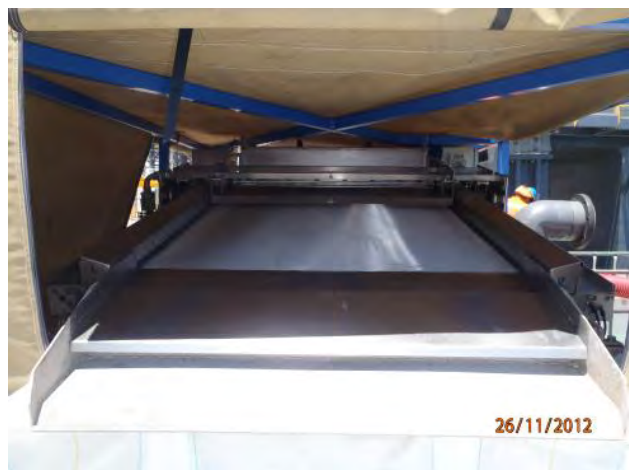
Figure 2.6 First stage filtration: filter screen

The trash pump lifts water and debris through a 4" hose to the first stage filtration system. This unit comprises a feed box which allows a consistent flow of feed slurry onto an inclined, static woven mesh screen (the *Baleen Filter*®) (Figure 2.6). Mesh size on the prototype unit is 50 µm, although finer mesh could potentially be used. Any oversize or near-size particles (including viscous emulsion, if present) are retained on the screen surface and the slurry filtrate passes through the mesh screen by gravity. The oversize material is fluidised from the screen surface by a low volume, high pressure water spray bar located below the surface of the screen and perpendicular to it (Figure 2.7). Concurrently, a similar spray bar located above the screen surface, and at a slightly forward orientation, flushes the fluidised bed of oversize material to the discharge end of the screen for collection in a disposable bin bag.

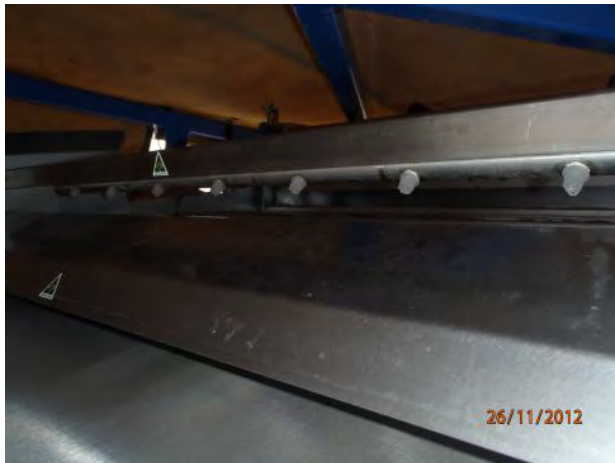
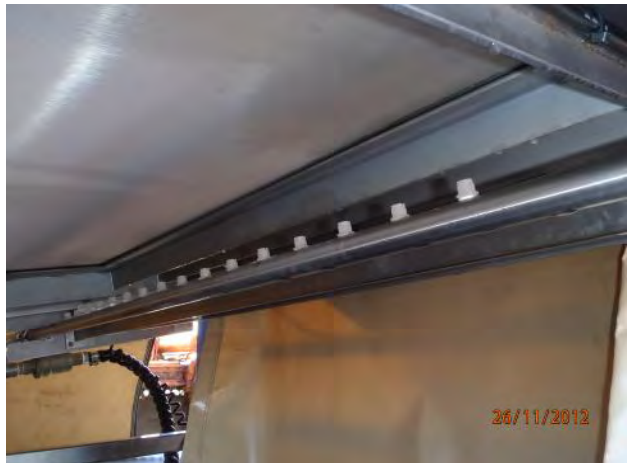
Figure 2.7 First stage filtration: upper and lower spray bars

The connected top and bottom spray bars travel down the screen in a pneumatically-driven carriage system. When the carriage reaches the lower limit of travel at the lower end of the screen, the spray water is cut off and the carriage returns to the feed end of the screen for the next cleaning cycle.

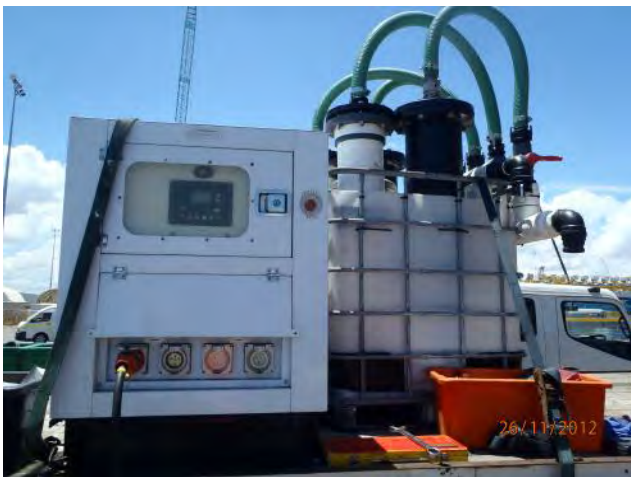
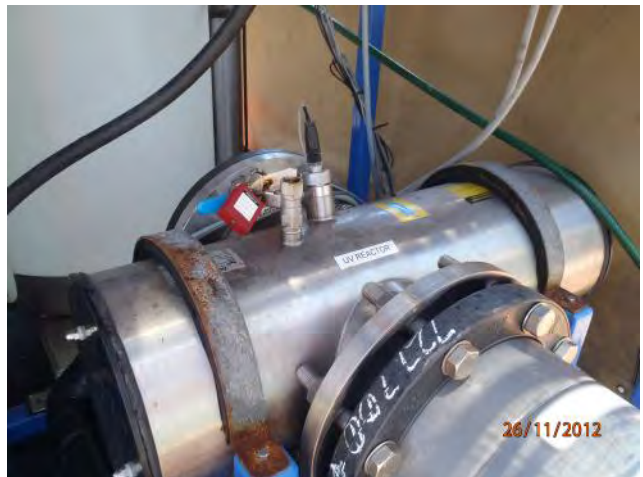
Figure 2.8 Second stage filtration assembly (left) and UV treatment unit (right).

Filtrate from the first stage filtration is further filtered by pumping it through a series of four back-flushable filter units that contain high volume, interchangeable, cartridge filters (3M™ High Flow 40" filter cartridges, 25 µm media grade) capable of removing particulate material greater in size than 2 – 5 µm (Figure 2.8). 3M™ internal laboratory testing determined the removal efficiency of these cartridges to be 98.93% for 3-5 µm particles (A Ng, 3M Purification Pty Ltd, personal communication 13 March 2012). The filters are regularly back-flushed when resistance increases (in practice about every 25 min), with the back-flushed water discharged back into the solids bin, drained, then recycled back through the filtration process. Back-flushing and cleaning re-generates 60% of a filter's efficiency, but ultimately the cartridges reach a maximum operating back pressure and need to be replaced. Filter units in the series

After filtration through both first and second stage filtration, the filtrate is disinfected by passing through an automated UV chamber (Figure 2.8). Filtered and treated water is then released for discharge, or can be contained and pumped into tankers for onshore disposal.

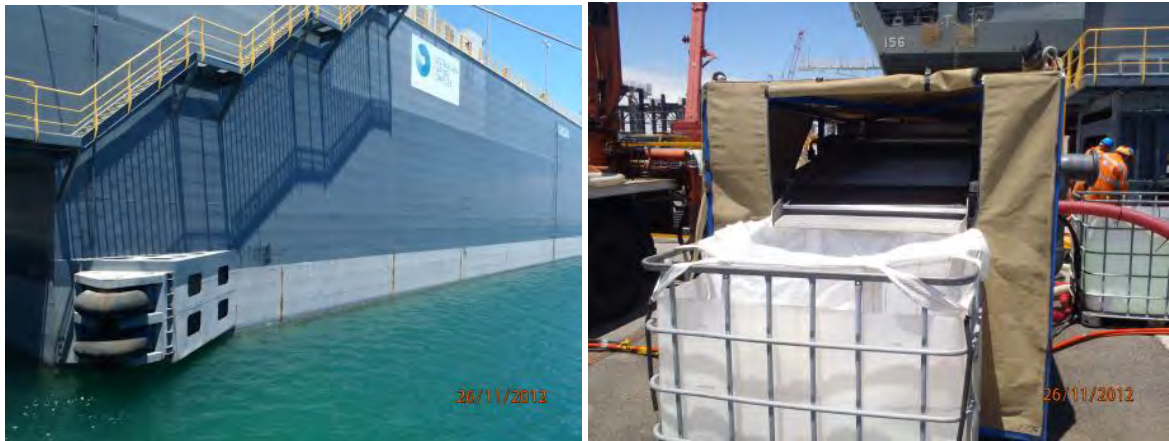
Figure 4.1 Dry-dock *Yargan* (left), and first stage filtration unit (right).

Trial 1 was undertaken on floating dry-dock *Yargan*, located at the Australian Marine Complex, Henderson, WA (Figure 4.1). *Yargan* is constructed of steel and underwater surfaces are painted with a high performance anti-corrosive marine paint system. The current top coat, applied in November 2007, is a two component epoxy coating, *PPG Sigmashield 420*. No antifouling coating, either biocidal or biocide-free, was applied.

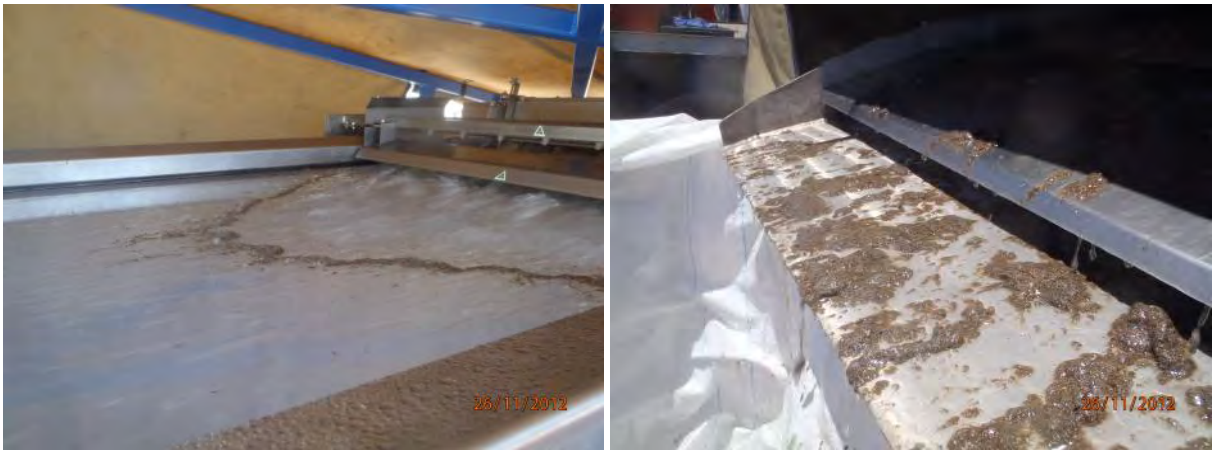
Figure 4.4 Debris greater than 50  $\mu\text{m}$  accumulating on the baleen screen (left) and washed into the waste bag (right).

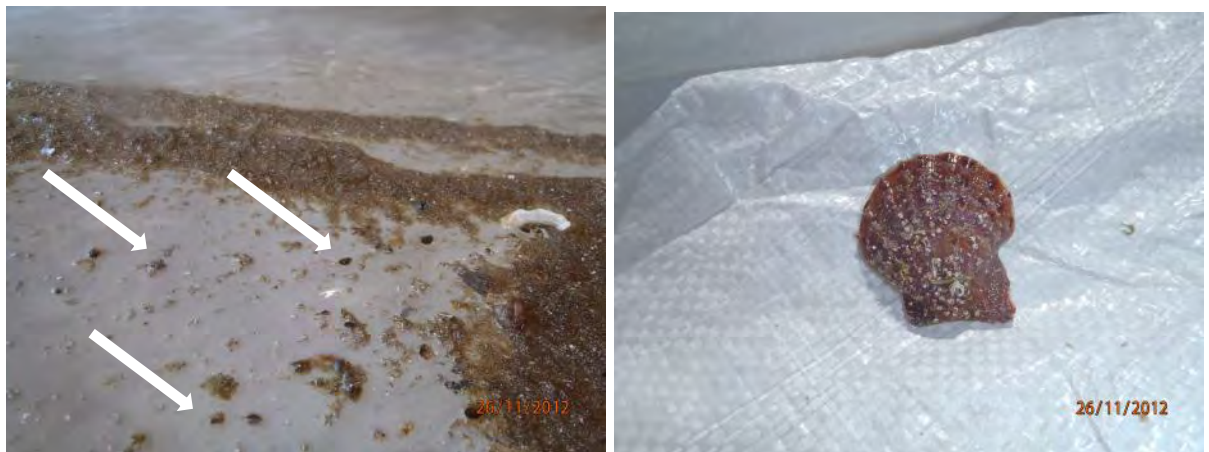
Figure 4.5 Captured debris, including juvenile mytilid mussels (arrowed) and an intact scallop (right).

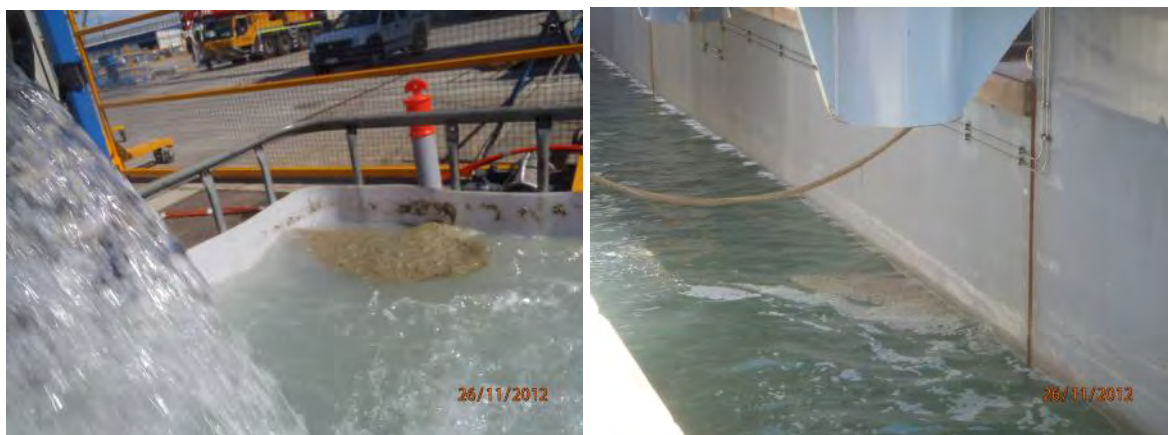
Figure 4.6 Organic scum derived from the filtrate in the discharge tank (left) and beside the *Yargan* (right).

In addition, fine organic material passing through the system was lifted to the surface of the water by entrained fine bubbles in the discharge tank and formed a surface scum. Some of this was discharged and formed a small plume in the seawater around the discharge stream.

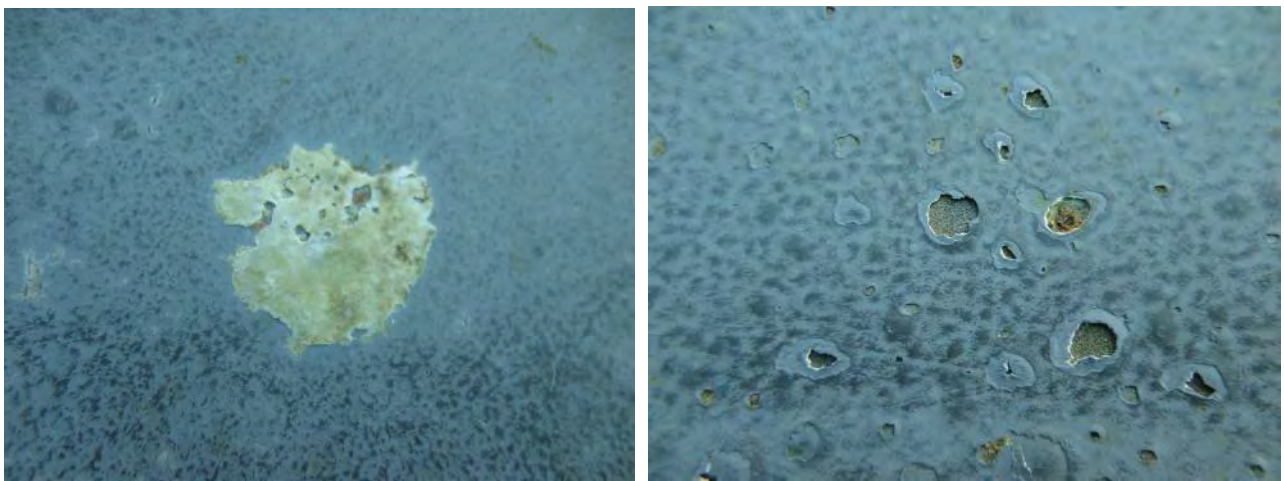
Figure 4.8 Residual oyster base (left) and paint blistering defects (right) on the vertical side.

After cleaning, smooth areas of hull plate were mostly visibly free of biofouling on both the vertical sides (Figure 4.7) and flat bottom (Figure 4.8). Biofouling encrustation did persist alongside hull irregularities, such as weld-lines, but on the flat hull plate only some scattered and isolated calcareous baseplate scars of oysters and tubeworms remained (Figure 4.9). The only mechanical damage to the coating from the cleaning was light scuffing from contact of the brushes. These would not compromise coating life or performance.

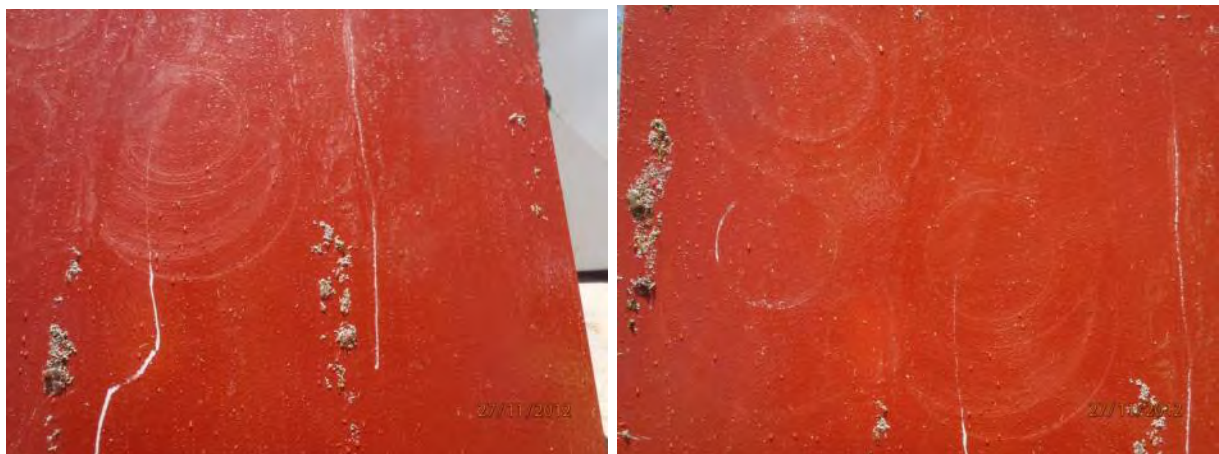
Figure 5.4 Scuffing of the coating surface caused by the blades touching the surface.

The cart passes in this trial caused two types of damage to the FR coating: elongate scratching of the silicone coating under the mid-line of the chassis (Figure 5.4), and light radial scratching and scuffing of the surface by the left-hand disc (Figure 5.5). The former was determined to be due to the hard plastic jockey wheel either jamming or dragging across the coating surface as the cart moved forward or, less likely, shell-growth being caught on around the jockey wheel and scoured across the paint.

The second type of damage was due to the blades on the left hand disc touching the coating surface. Although the blades had been set to ensure they did not do this, it was found that the bolts holding the left-hand blade disc had loosened causing the disc to wobble and touch the surface. On inspection, blades on this disc had traces of paint on their inner edge. The track under the right-hand disc showed no sign of scratching or scuffing, and the surface was completely free of any visible micro- or macro-fouling.

The loosening of the disc was determined to be an operator error that could be addressed by closer scrutiny to the disc set-up before deployment. The problematic jockey wheel requires redesign of the wheel shape or material to prevent jamming and/or dragging on silicone elastomer coatings.

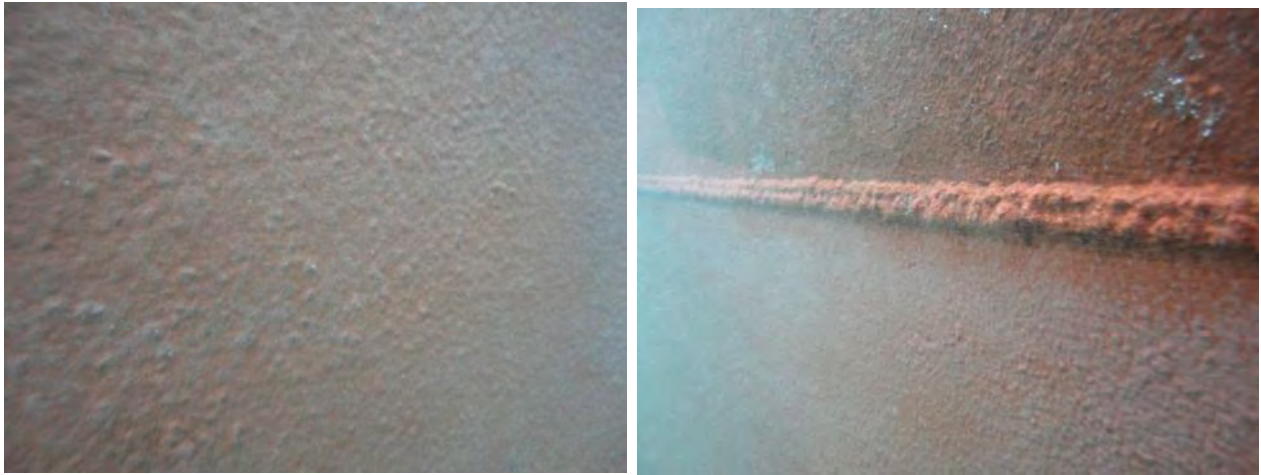
Figure 6.4 Hull surface after cleaning with the *Envirocart* fitted with bladed discs.

Cart cleaning with both the bladed disc and brushes completely removed the biofilm, and caused no visible damage to the underlying coating (Figures 6.4, 6.5). No plume of either paint or organic debris was visible around the cart during the clean. Removal of the biofilm and leached surface layer of the paint would not cause accelerated deterioration or aging of the antifouling system but, rather, regenerates the antifouling mechanism by restoring the biocide leach rate to, or close to the design rate for the system

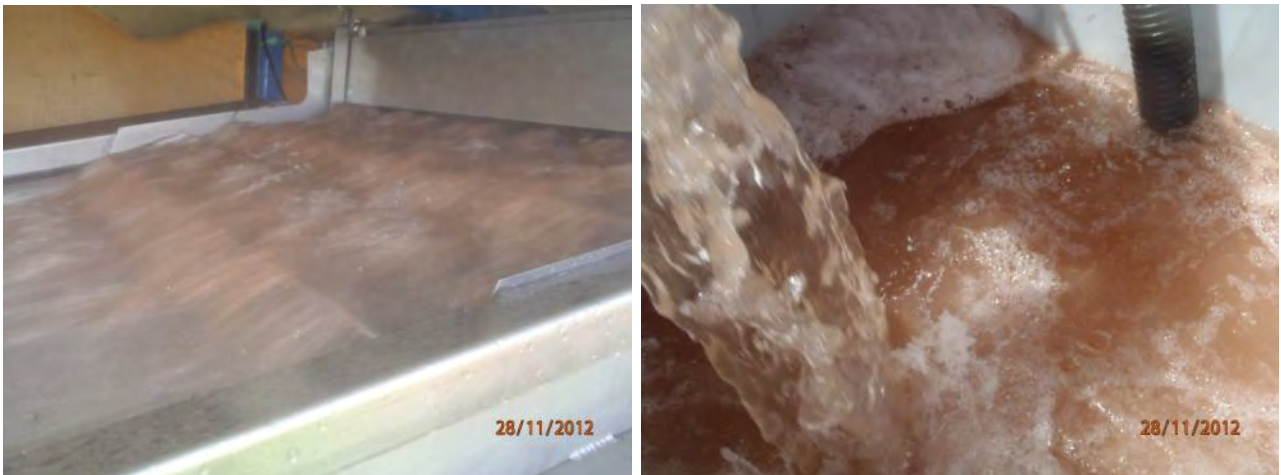
Figure 6.7 Red (copper) tinted water flowing over the first stage filter (left), filtrate in the tank below the filter tray (right), during the *Wambiri* hull clean.

As expected, copper concentrations were much higher in the cleaner effluent due to the removal and capture of degraded surface layers of the paint by the cleaning action (Tables 6.4.2.3, 6.4.2.4). Notably, copper concentrations in effluent from the cleaner fitted with the blade head were much lower than those generated by the brush head. Levels of cadmium, lead and tin were all below, or very close to, the limit of detection for the analytical methods used for these metals.

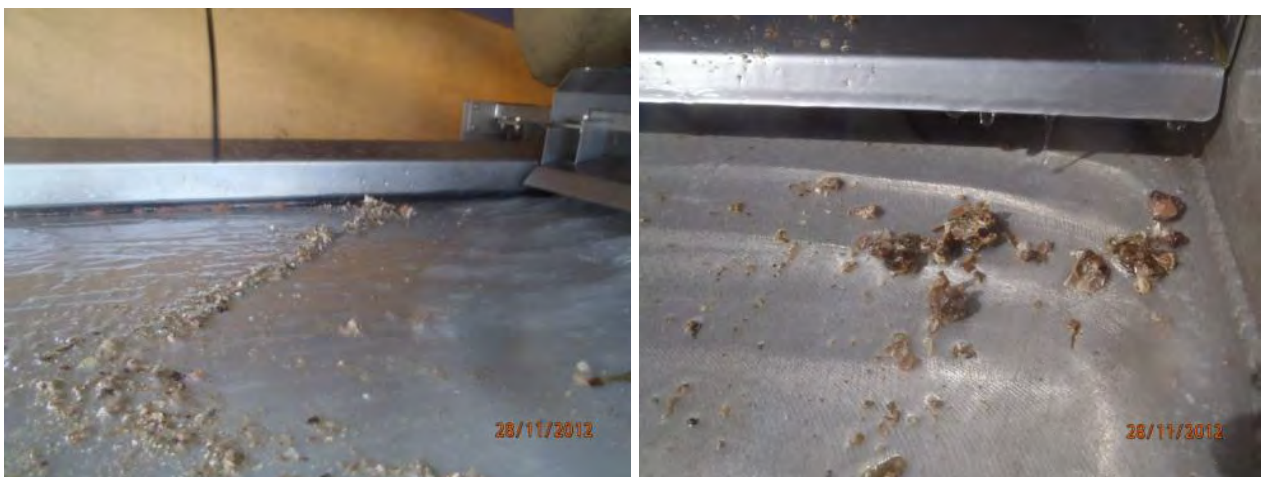
Figure 6.8 First stage filtration debris from the box clean of the *Wambiri* anode (left), and scraper clean of the jetty pile (right).

Removal of biofouling growth from the wharf pile with the shrouded blade was effective and growth scraped from the surface was drawn into the suction pipe. The observed limitation of the technique related to the severity and thickness of the fouling on the surface. The depth of the fouling exceeded the height of the shroud, and the diver was required to hold clumps of fouling as they were scraped from the surface, and direct them into the suction shroud to ensure they did not fall away from the scraper.
