Hull Camera: Preliminary Design and Testing of its use for Assessing Biofouling on Small (<12 m) Recreational Vessels

Fisheries Research Reports

Bridgwood, S.D., 2010. Hull Camera: Preliminary Design and Testing of its use for Assessing Biofouling on Small (< 12 m) Recreational Vessels. 2010. Fisheries Research Report No. 200. Department of Fisheries, Western Australia. 16 p.

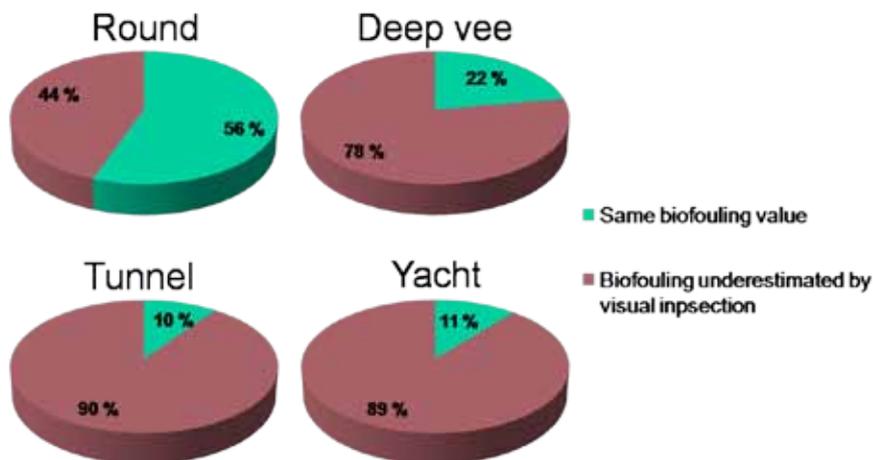
Results for individual areas highlight the gap in the assessment of biofouling if only made based on waterline inspections. For three of the boat hull shapes (deep vee, tunnel and yacht) very few of the different areas assessed actually showed agreement between the biofouling scores for waterline inspections and the hull camera (Figure 9). The round hull showed the best agreement between the two biofouling methods, however there was still a 44 % underestimation of biofouling scores (Figure 9).

Figure 9. The percentage of agreement between biofouling values for waterline inspections and the hull camera.
